Inglenook House, Main Road

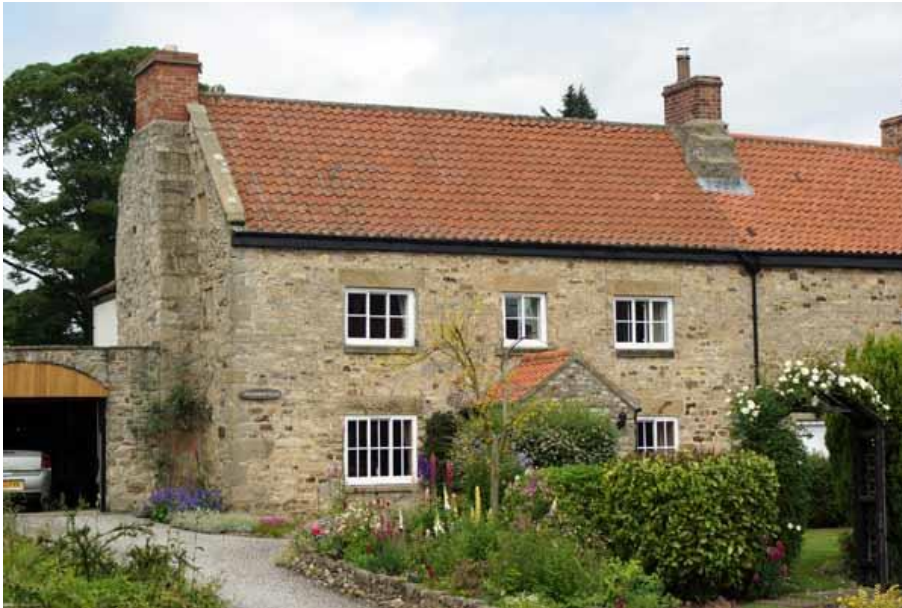
Section: Either a three-unit house or a two-unit house with a one-cell cottage (The Cottage) attached. Central doorway with symmetrical window layout.

Walls: Uncoursed rubble with large semi-dressed quoins. There is an uncoursed rubble porch. A substantial uncoursed rubble built chimney is situated on the gable end, giving rise to an inglenook inside. The chimney on the other side of the building would, from the stepped stone work showing above the new pantiles, appear to have been another inglenook gable end chimney.

Roof: Pan-tiled with parapet at east gable end.

Windows: The ground floor windows are twelve pane horizontal sliding windows with stone lintel and sill. On the first floor there are two six pane side-sliding windows with a four pane side-sliding located centrally over the door. All have stone lintels and sills. On the gable end is a blocked single-light window with chamfered surround to the first floor and loft.

Door: Wooden door with wooden architrave set in wall stone.

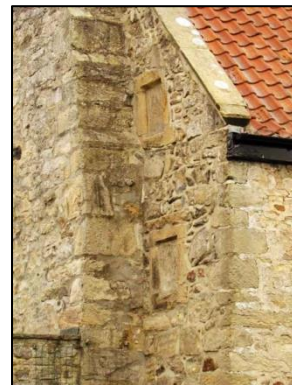
Points of interest: Inglenook chimneys (described above).
